# HAZARD ALERT

## Multi-Piece Rims

*Lethal Hazards Part of Rim Repair Work*

### Accident Summary

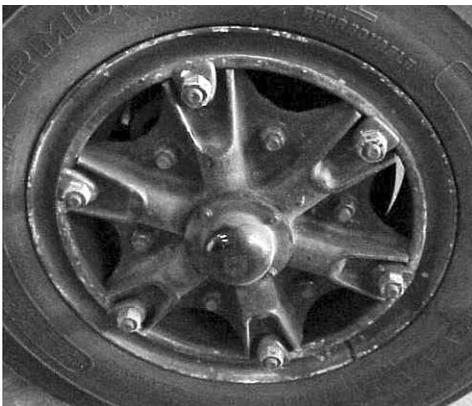
*Typical six spoke wheel on a bus.*

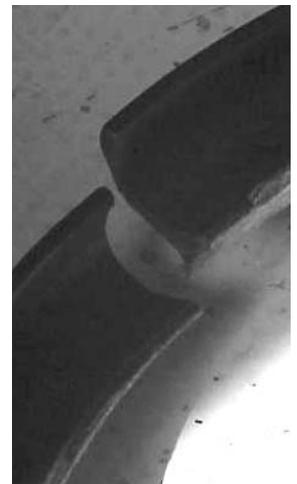
*Close-up of rim at split.*

The split side ring markings were illegible because the ring had been painted over with black paint four months earlier. When the paint was scraped off, the split side ring markings showed the ring was mismatched with the rim base and had been damaged when it was mounted previously or had been bent during the accident.

If the rim is painted or the markings otherwise illegible, the wheel and tire assembly should not be serviced.

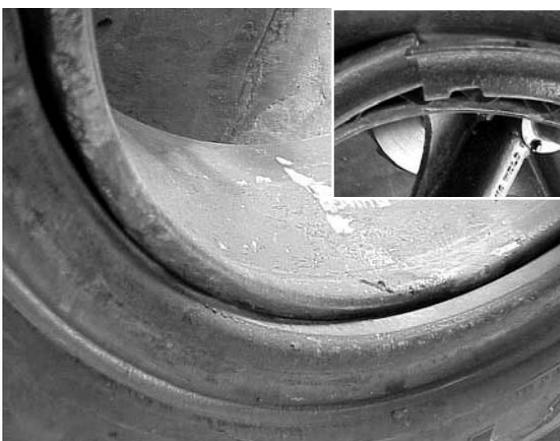
*Inner wheel with tire mounted. Inset: Close-up of split rim against mounted tire.*

The victim had been disassembling the wheel thinking that it had been put together according to the manufacturer's specifications. The employee had no reason to believe the mismatched split side ring and the rim base were not properly seated. The tire was properly inflated and had been driven for about four months before the incident.

- The split side ring was not completely seated and locked.
- Rim gutters and ring must be free of any surface rust that could obstruct seating of the ring.
